## On-site Repair of a HVDC Transformer

This paper presents the setup and application of technology to on-site repair of a high voltage converter transformer.

In short, this paper presents a general view of on-site repair steps of a HVDC converter transformer combined with the corresponding manufacturing steps at factory, including drying and on-site routine and high voltage electric test processes.

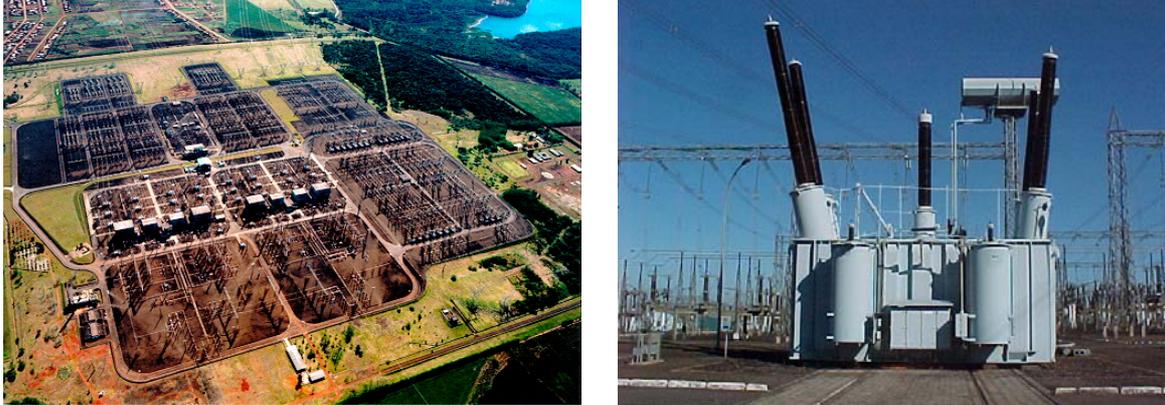
Figure 2 – Itaipu Electric Power System: Foz do Iguaçu Converter Station and the HVDC Converter Transformer Single-Phase, 314MVA, 600kV

Early in the year 2002, an electric failure damaged one of the converter transformers installed at Foz do Iguaçu converter station. The involved unit is single-phase, two wounded limbs, 50Hz, 314MVA rated power,  $\pm 600\text{kV DC}$  ( $550/\sqrt{3}$ - $127/\sqrt{3}$ - $127\text{kV}$ ) rated voltage and 420tons of total mass. The repair requires complete replacement of the winding blocks.

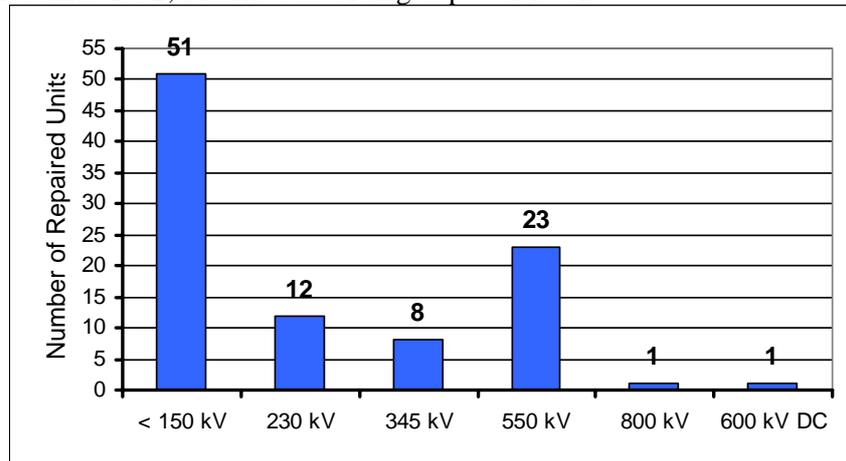
Figure 6 shows 96 transformers submitted to complete on-site repair (including winding replacement) in South America since 1992, stratified according to power levels.

Figure 4 – On-Site Complete Repairs from 1992 to 2003

On-site repair results show that the transformers present reliable performance. Since 1992, it has accumulated more than 425 transformers x year operation after on-site repair. Additionally, long-term performance monitoring of transformers already repaired, under actual conditions of electric power systems, has also qualified the process used for on-site repair of HV power transformers.

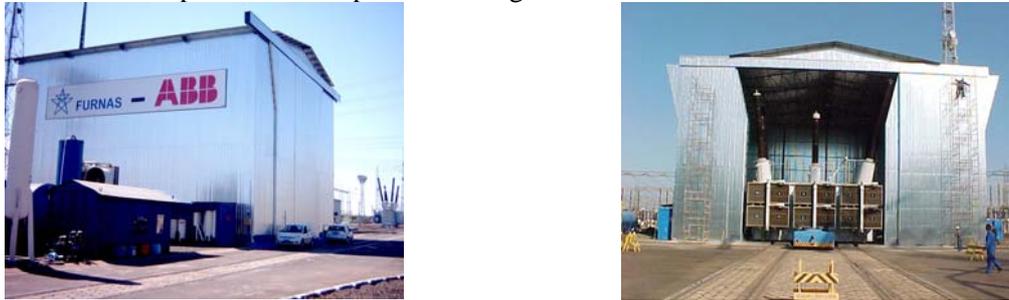
meters high (designed for 150km/hours wind speed and tight to heavy rain). Internally to the metal house, an internal extraclean room is assembled which has controlled environment for the active part assembly work. Figure 5 shows an external view of the metal house and hauling operation of the assembled transformer prior to active part untanking.

Figure 5 – Site Facility: Metal House

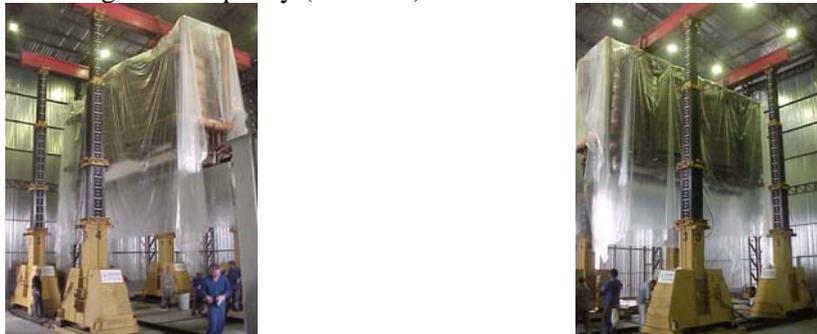
The transformer's active part is about 180tons. For active part untanking, mobile self-propelled lifting equipment is used with high load capacity (400 tons).

Figure 6 – Site Facility: Lifting Equipment

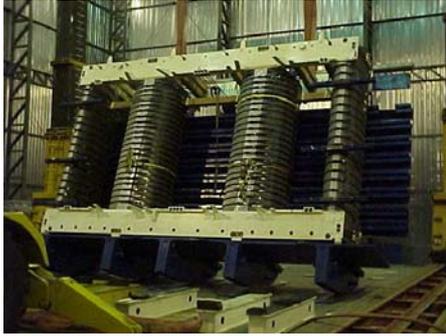
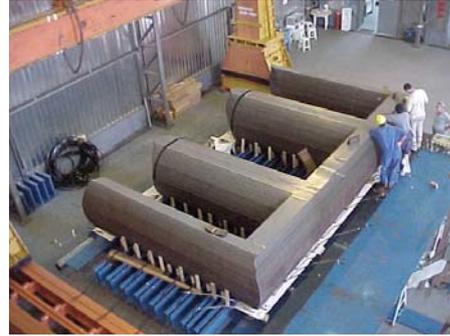
- opening of the upper core frame and disassembly of the core upper yoke;
- opening of all internal leads connections and disassembly of the HV winding connections and pressboard leads support structure;
- disassembly of windings, main insulation and core-winding insulation. Windings are removed from the core limbs through special lifting devices driven by a mobile auxiliary crane;
- core repair, including replacement of the complete core insulation from pressboard to fiberglass material and core retightening. Naturally, this operation requires that the core be in horizontal position. A mobile core stack table with capacity for 180tons has been used for this purpose;

Figure 7 – Core Repair (assembled core mass: 173tons)
